Yakima-Tieton Irrigation District

Photo Recap & Update

Wednesday, December 18, 2024

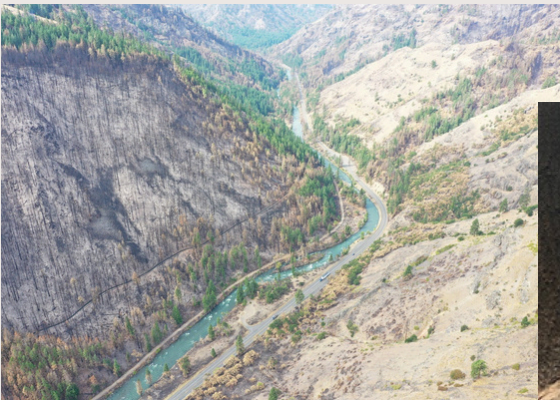
Aerial view large burned area west of Windy Point campground and canal that is now covered.

Thanks to the tireless efforts of our crews, engineering team, and the guidance and help from so many of you, we've stabilized critical areas of the canal. So far, nearly 6,000 linear feet of cover have been installed, and we're on track to hit 7,000 by the end of the year.

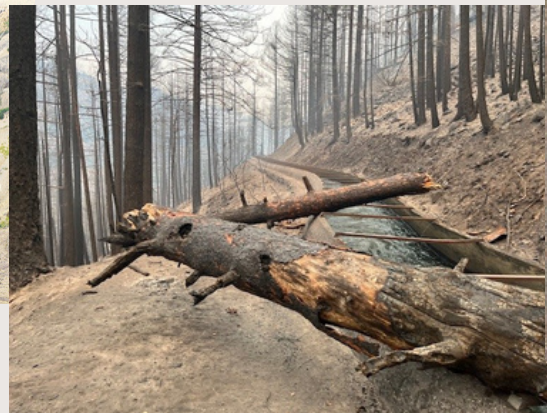
Before: Burned trees fall on top and into canal posing serious risk of catastrophic failure. Dozens have been removed but thousands of dead standing trees remain a threat.

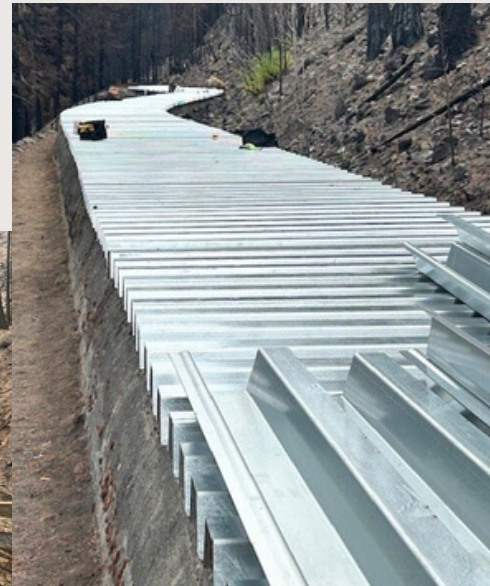
After: One section of the 6,000 linear feet of new cover installed. 10,000 feet of vulnerable area identified as highly vulnerable areas.

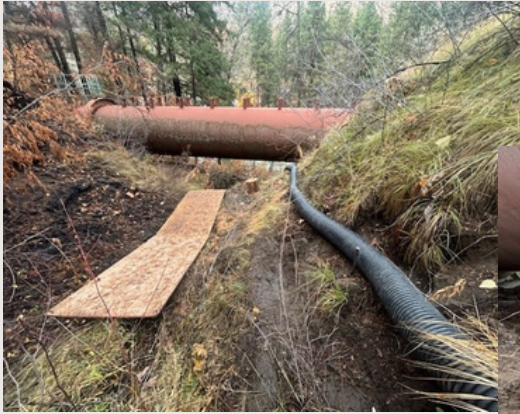
Before: Pipe bridge #1 with insufficient clearance for potential upcoming flooding & debris flow.

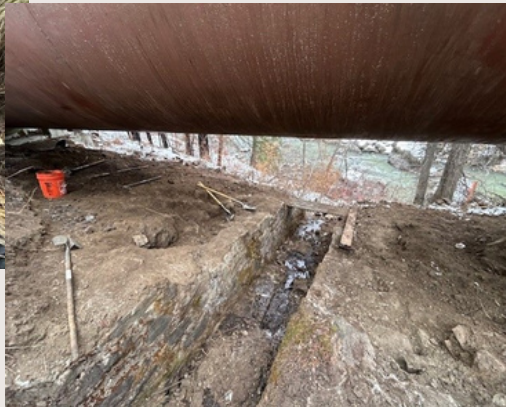
During Construction: Pipe Bridge #1 excavating an original drainage channel to increase clearance.

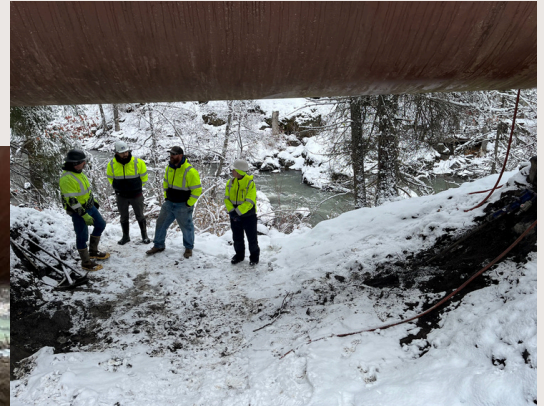
After: Pipe bridge #1 Now with adequate space to permit debris and water to pass underneath.

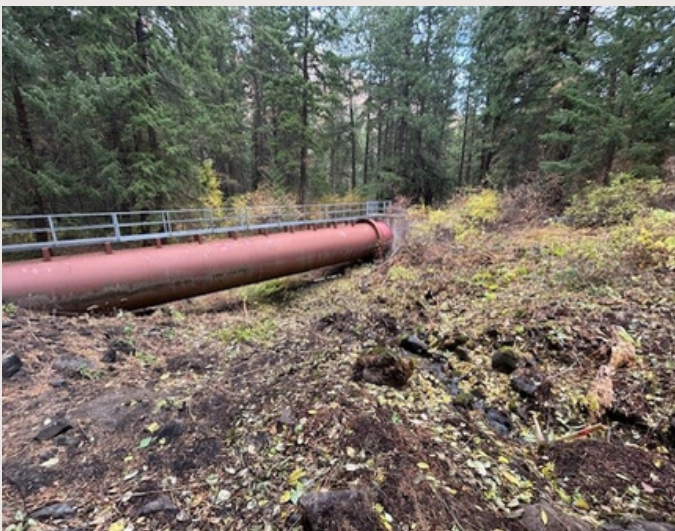
Before: Pipe bridge #2 upstream channel at risk and highly vulnerable to spring flooding and debris blockage.

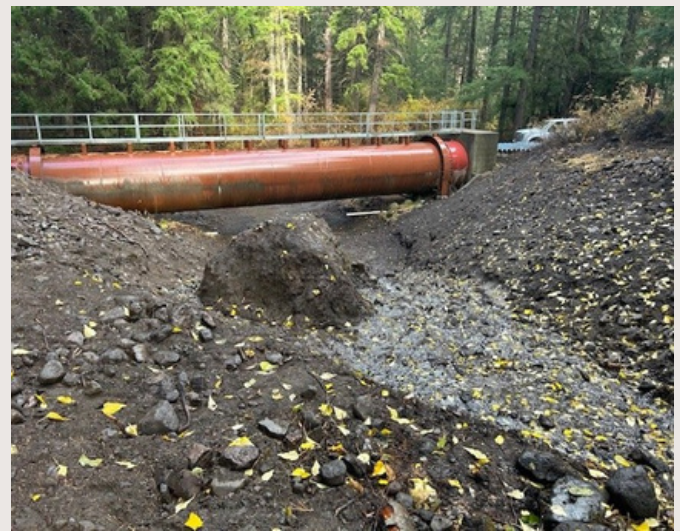
After: Pipe bridge #2 Significant material removed and channel open. (Note previously covered boulder).

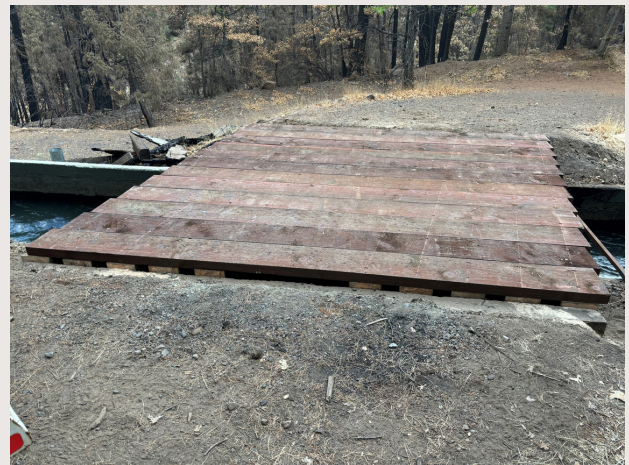
After: Bridge rebuilt by district crews.

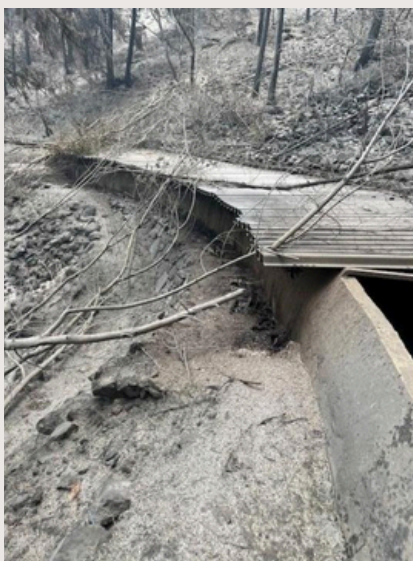
Before: All timber structures were lost in the fire, including cribbing meant to keep the weight of heavy cover off of the canal.

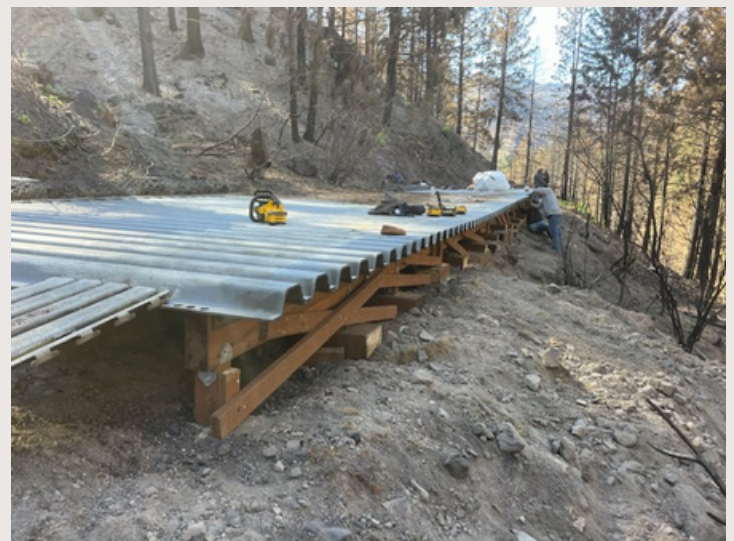
After: Timber cribbing re-installed at many locations to keep heavy decking from resting atop canal.

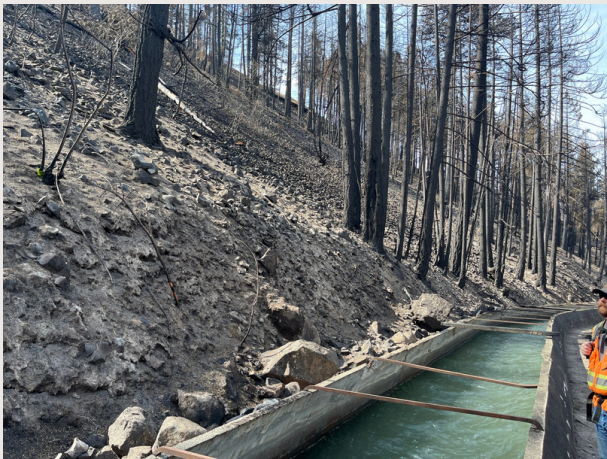
Before: Unstable burned terrain causing boulders to roll down the hill into the canal; conditions are anticipated to worsen in the spring due to lack of vegetation.

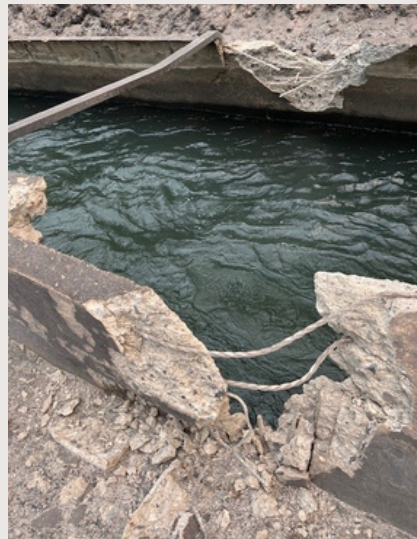
Boulder damage to canal.

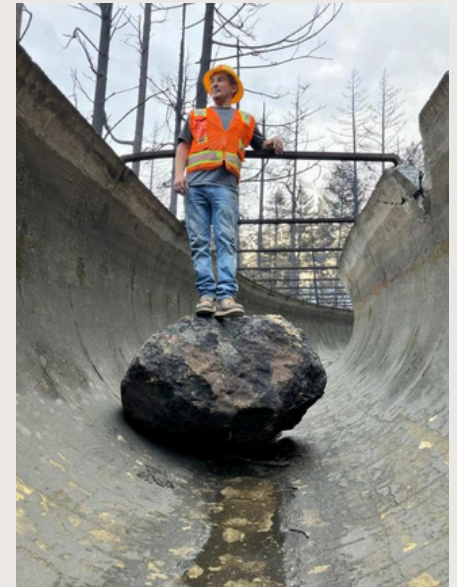
The boulder that caused the damage.

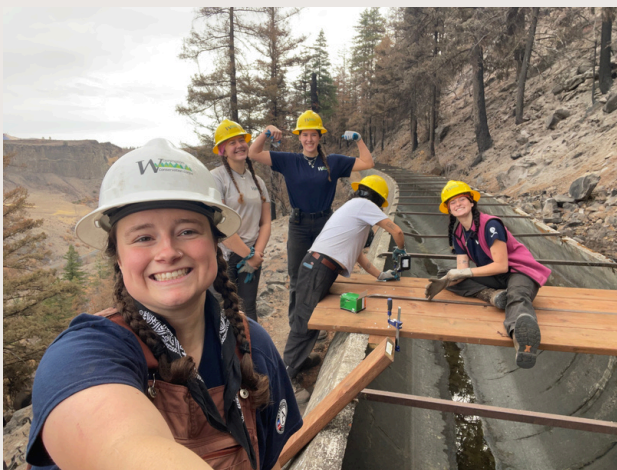
Washington Conservation Corps (WCC) crews completing wildlife crossings.

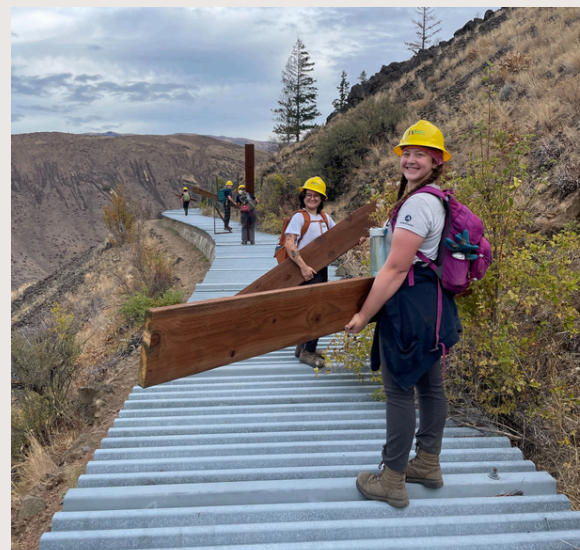
WCC crews staging materials for wildlife crossings.
